Navigational/Pilotage notes for River Tamar Between Pentillie Castle and Morwellham

Compiled by Michael Tucker and Rupert Hancock 11th March 2012. As you would expect, the authors accept no responsibility for all their errors and omissions and, as usual, you navigate entirely at your own risk.

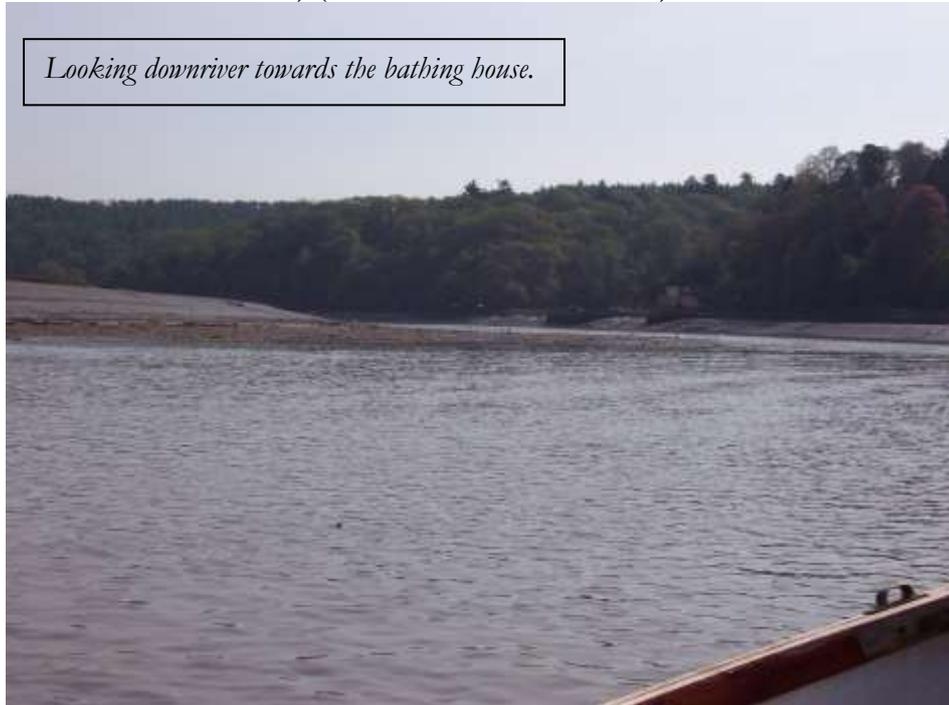
- There is a shallow spit drying 0.1 LWS on the Devon side opposite Pentillie bathing house (called "Boat house" on charts) (Photo below taken in 2011).

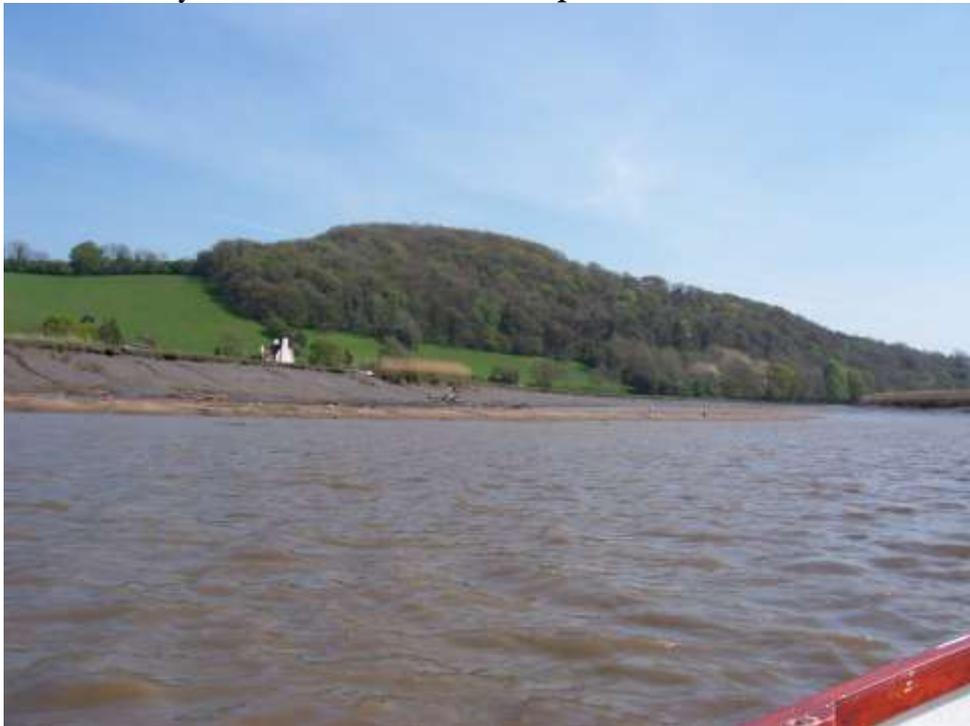
- North of South Ward Farm there is a 200 metre long spit in the centre of the river, around 20 metres wide, and at its northern end it is joined to the Devon Bank. (Photo below taken in 2011). Therefore it is essential when heading upriver to stay west of the river centre after South Ward Farm. “Sounding” could be a failure if it leads a vessel into what becomes a dead-end.

Both AC and Imray are now inaccurate at this point.

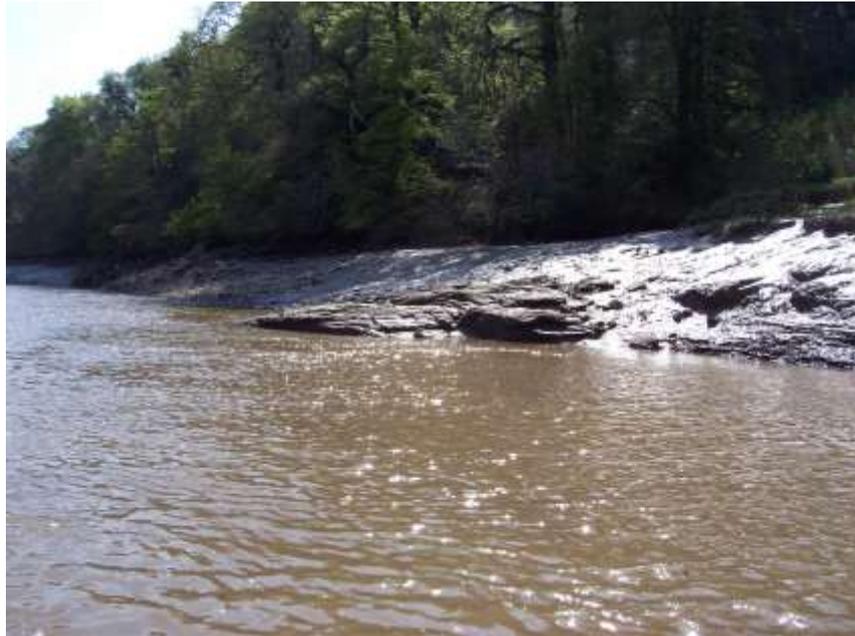
- On Cornish bank just downriver of Cotehele, there is shown a ruined quay. Immediately beside this quay is a rock projecting 10-15 metres from the grass bank into the river and drying approx 0.5 above LWS. **This rock extends a further 3 metres into the river centre approx 0.25 below LWS.** The position is N50 29.379 W004 13.446 (photo below taken in 2011)

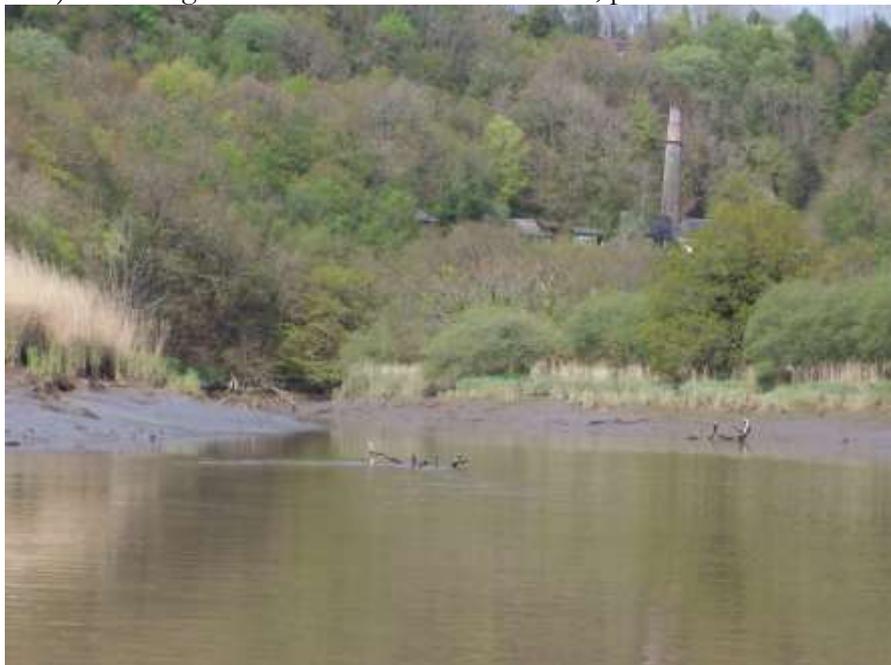
- N of Cotehele, there is a rock close in on Devon side at N 50 29.618 W 004 13.216 at the end of and in line with the moorings. The trees will probably keep you away from the bank at this point but keep clear anyway.
- At N 50 29.793 W 004 13.278 There is a tree on the Devon side of the river
- At N 50 29.649 W 004 12.352 There is a tree on the Cornish side of the river.
- At N 50.29.533 W 004 12.106 There is a tree, also on the Cornish side of the river.
- **At N 50 29.803 W 004 11.649 There is a tree 1/3RD of the way across the river,** (photo below taken in 2011) and being nearer to Devon than Cornwall, pass it on its west side.

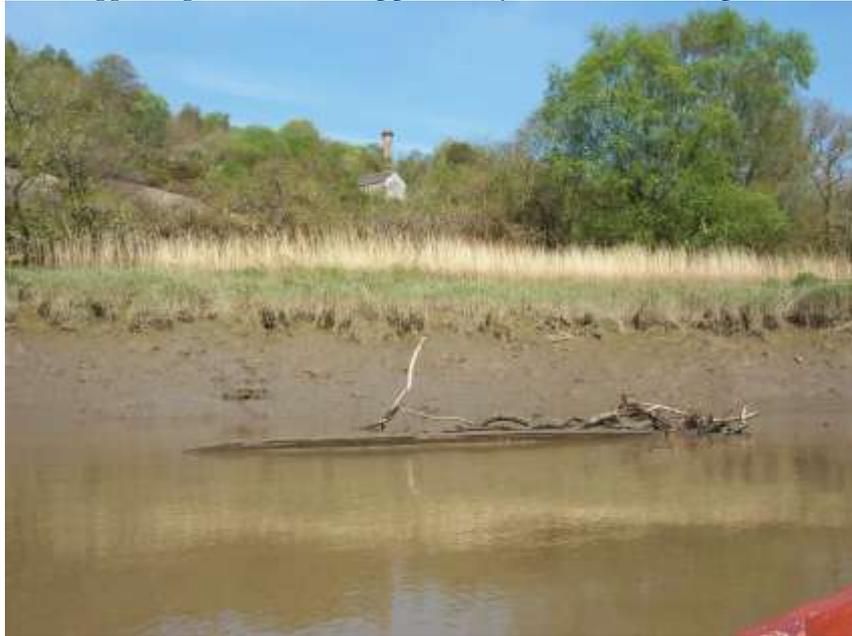
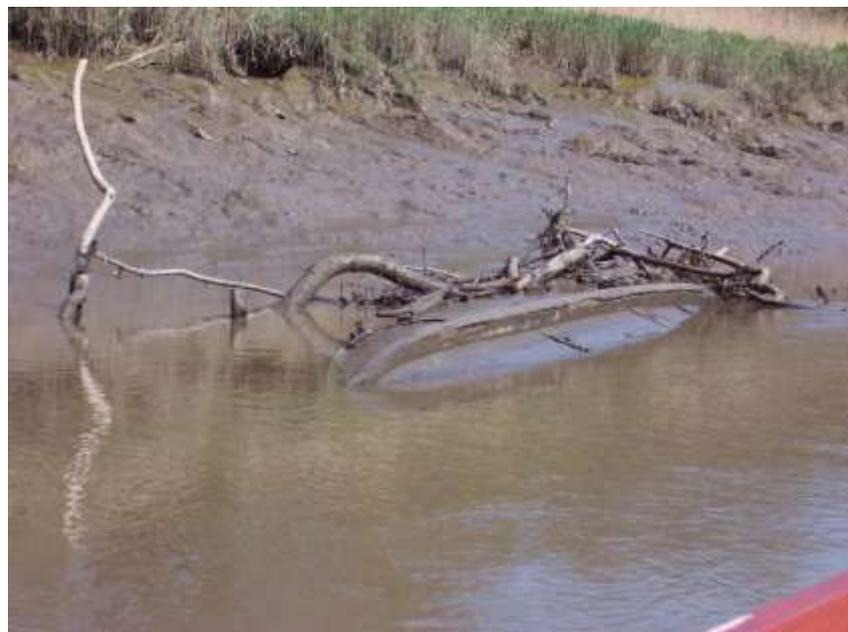
- The furthest upriver we ventured was to N 50 30.208 W 004 10.826, where we anchored in 1m depth, 2 metres from Devon Bank (Mid stream was 1.5 metres (HW+6)).
- At N 50 29.989 W 004 11.080 there is a large wreck driven into the Cornish bank thought by old men with vivid imaginations to have once been a pirate's ship. Not a hazard to navigation (any longer).
- At 50 29.934 w 004 11.562 there is a wreck, dries 0.2 at LWS. (Photo below taken in 2011). This is on the Cornish side of the river, and **definitely a hazard to navigation**. This wreck lies bows downstream, it's approx 20 feet long, upside down, is made of wood (teak?) and has two big lateral scars suggesting it had been supported by 2 wires at some point in its life.
